Roof Issues

A Case Study in Roof Problems

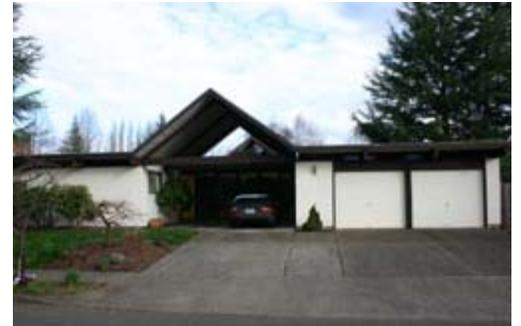
The Oak Hills double gable Rummer featured here provides a good illustration of roof issues that might be encountered. The owner actually had a new roof installed a few years earlier both on the gabled portion of the house and on the flat roof areas. The new roof seemed to solve the leak problems that had been occurring prior to its installation. However, it is suspected that a new leak resulted from improper chimney flashing when the gable portion of the roof was installed. Water entered high up on the gable where the chimney and roof meet and flowed down the gable under the roof shingles and collected where the gable and the flat roofs join. Eventually this resulted in dry rot in the 2X6 tongue and groove roof decking along the juncture of the gable and flat roof areas.

Because of the post and beam construction and the exposed roof decking, the rot damage to the decking became visible from the underside. It was especially noticeable on the exterior of the house under the broad eaves, but it was also developing in the interior. What made matters more interesting, rot was also developing in the cantilevered exterior portion of the 4"X12" structural beam that runs along and supports the roof system at the juncture of the gabled and flat roofs. The damage to the exposed exterior portion of the beam was severe, requiring replacement. Because the portion of the beam was cantilevered, the beam would need to be replaced back to at least twice the length of the cantilevered portion. As noted, damage in the roof decking was visible on the interior of the house in the living room. But the beam at this point was concealed behind the paneling of the wall separating the living

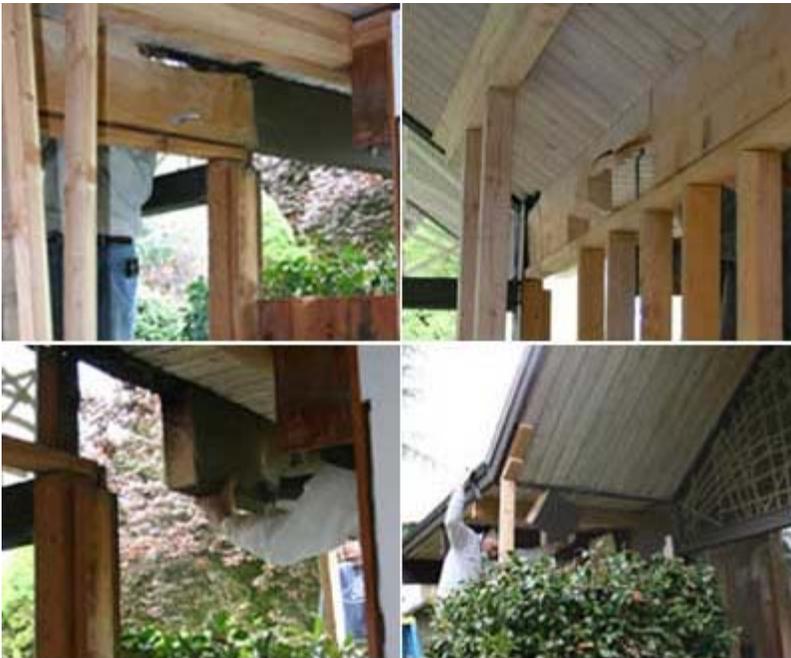
sectioning, prying out and removing the damaged beam

First step was to build temporary shoring to support the roof structure while the beam was removed. This was done for the gable portion in the living room and the flat roof over the master bedroom. With the roof temporarily supported, the portion of the beam to be replaced was cut into sections using a reciprocating saw.

These sections were removed using pry bars, sledges and elbow grease. Once the old beam sections were cleared the damage to the roof decking was clearly visible as can be seen in the photos below.

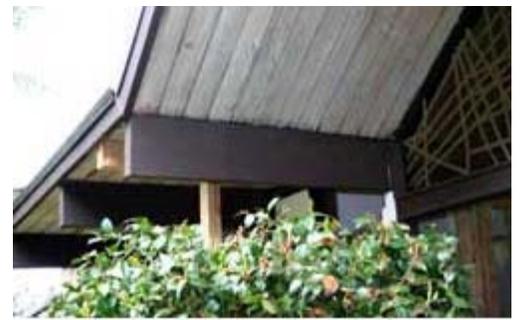
damage is visible along the beam

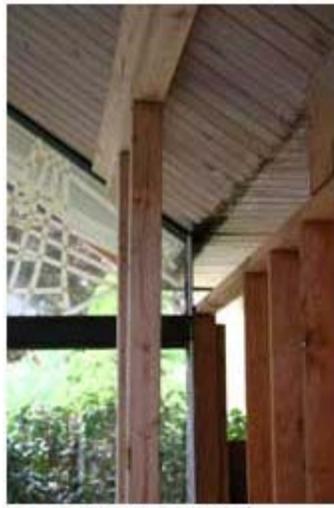
beam removed

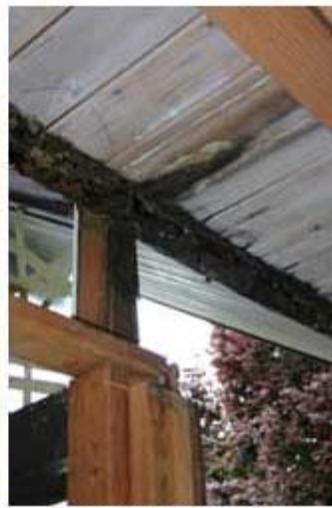
damaged roof decking

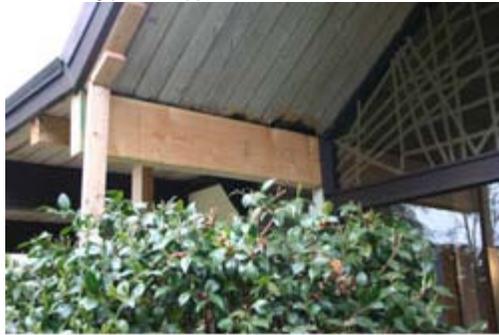
exterior view of new beam in place

The new beam was cut to length. In the original construction the top of the beam had been notched to accept the decking coming down from the gable and the decking over the flat portion of the roof. The contractor reproduced this joint on the new beam using a circular saw. Getting the new beam into place was a bit of a challenge, but after a couple of attempts it slid into position. The new portion of the beam was tied into the portion still in place and secured to existing posts/supports.

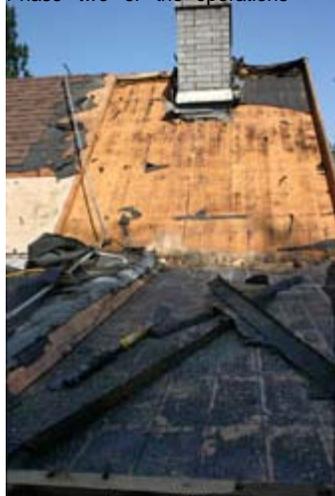
roof peeled back

was to peel back the roof so that the damaged decking could be replaced. The roofing contractor first removed the composition shingles from the gable portion of the roof along with the original and extra insulation which had been added over the years. Then the membrane material over the flat deck was cut away, insulation removed and the decking exposed

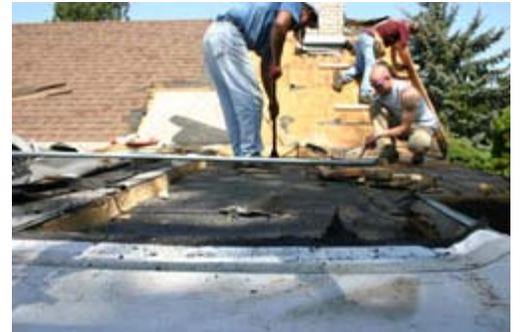
Once the roof materials were removed the damage to the decking is clearly visible

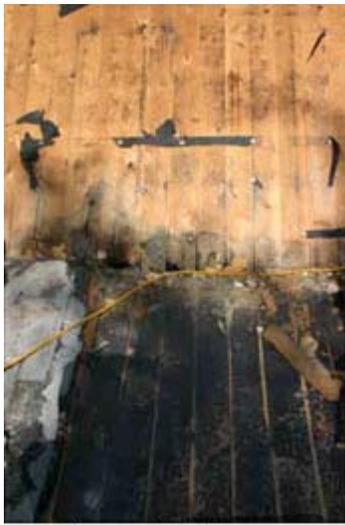
damaged decking

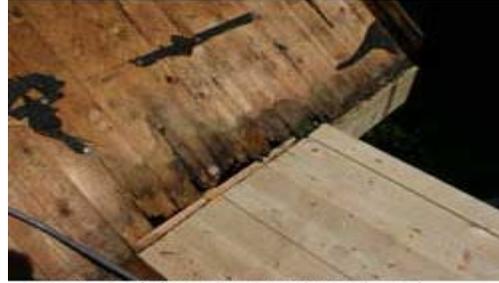
some deck boards already replaced
in this photo

The flat decking boards were removed and replaced first, and the gable portion followed. The contractor made sure that Hemlock was used in replacing the roof decking. "Most people look at the decking on these Rummer houses and think that it is Douglas Fir. That is not the case. If you want to match the original materials you'll almost always find that it was Hemlock."
