Roof Issues

A Case Study in Roof Problems

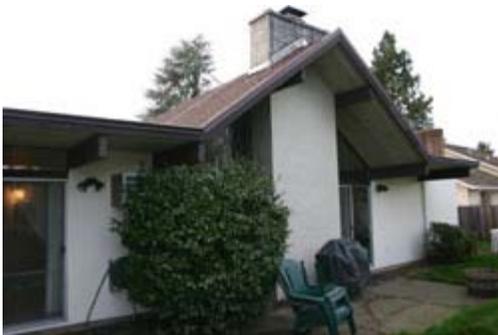
The Oak Hills double gable Rummer featured here provides a good illustration of roof issues that might be encountered. The owner actually had a new roof installed a few years earlier both on the gabled portion of the house and on the flat roof areas. The new roof seemed to solve the leak problems that had been occurring prior to its installation. However, it is suspected that a new leak resulted from improper chimney flashing when the gable portion of the roof was installed. Water entered high up on the gable where the chimney and roof meet and flowed down the gable under the roof shingles and collected where the gable and the flat roofs join. Eventually this resulted in dry rot in the 2X6 tongue and groove roof decking along the juncture of the gable and flat roof areas.

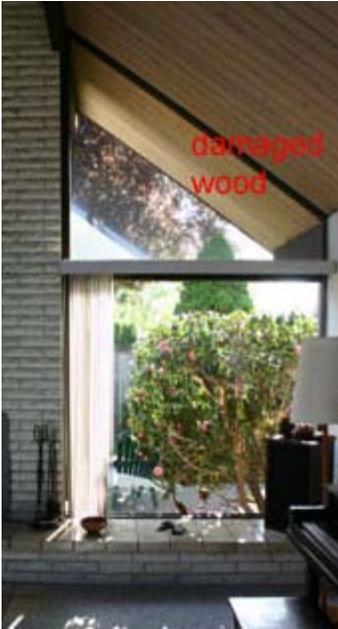
Because of the post and beam construction and the exposed roof decking, the rot damage to the decking became visible from the underside. It was especially noticeable on the exterior of the house under the broad eaves, but it was also developing in the interior. What made matters more interesting, rot was also developing in the cantilevered exterior portion of the 4"X12" structural beam that runs along and supports the roof system at the juncture of the gabled and flat roofs. The damage to the exposed exterior portion of the beam was severe, requiring replacement. Because the portion of the beam was cantilevered, the beam would need to be replaced back to at least twice the length of the cantilevered portion. As noted, damage in the roof decking was visible on the interior of the house in the living room. But the beam at this point was concealed behind the paneling of the wall separating the living

room and the master bedroom. This wall needed to be opened up, removing the paneling, to determine how far into the interior portion of the house the decking and beam damage extended.
